New York State Department of Transportation General Bridge Inspection Report

Inspection Date: November 03, 2021

BIN: 1069090
 Region: 03 - SYRACUSE

Feature Carried: I481 SB TO I81 SB
 County: ONONDAGA

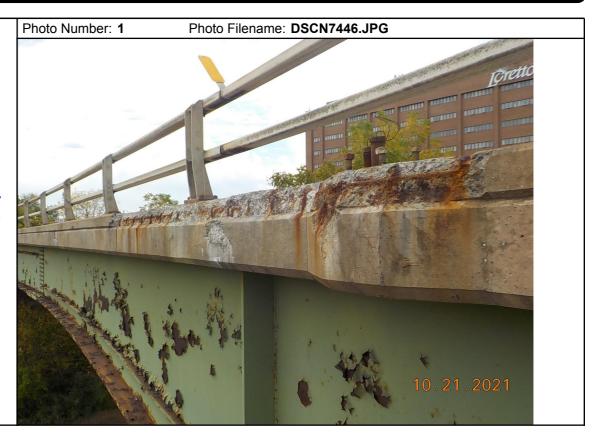
Span 1: There is a spall up to 15' L X FH of coping X 2.5" D with exposed corroded rebars along the right fascia of the coping from the end of span between bridge rail Post 3 and 4 (Photo 1).

Attachment Description: Spans 1 and 2 right fascia deck near pier 1. Looking Begin Left

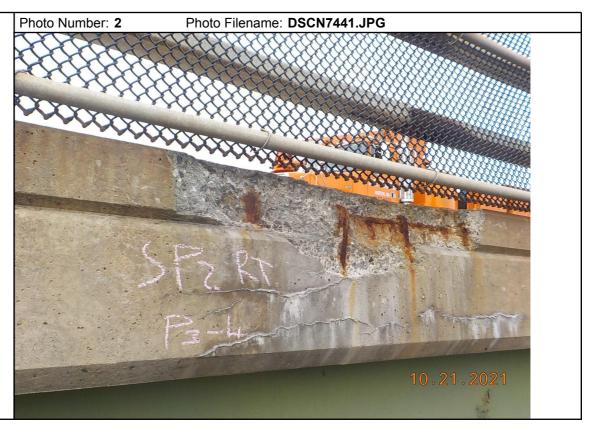
Span 2: There is a spall up to 8' L X F H of coping X 2.5" D with exposed corroded rebars along the right fascia of the coping from between the bridge rail Post 3 and 4 (Photo 2). Similar condition at the right fascia coping between Post 1 and 2.

Attachment Description: Span 2 right facia deck between Post 3 and. Looking End Left

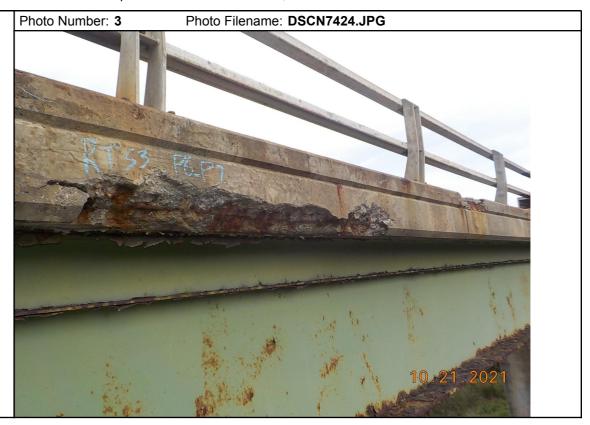
Span 3: The right fascia deck has a 10' L X 1.2' H X 3" D spall with exposed corroded rebars between bridge rail Post 6 and 7 (Photo 3).

Attachment Description: Span 3 right fascia deck between Post 6 and 7. Looking End Left

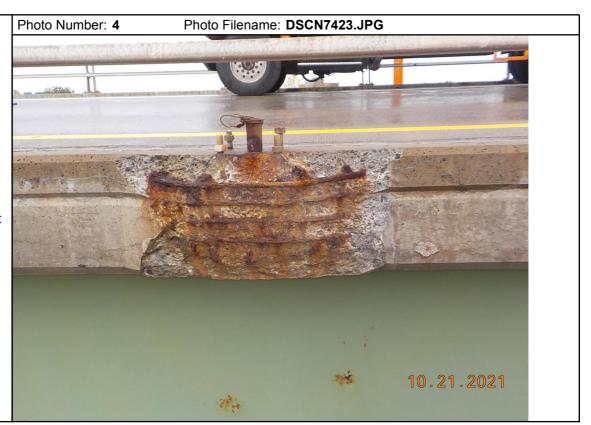
At the light pole anchorage at the right the fascia is spalled FH x 3" deep with exposed corroded rebar (Photo 4). There are spalls up to 8' L X 1' H X 2.5" D with exposed corroded rebars along the right fascia of the coping from the end of span between bridge rail Post 1 and 2 (Photo 5).

The right light poles in Spans 2, 3 and 4 are missing (appear to have been intentionally removed in the past). There are exposed wires at all 3 of these locations (Photos 4,7). It is unknown if the wires are live. No flag is issued since pedestrian traffic is prohibited on this roadway.

Attachment Description: Span 3 right fascia old light pole base. Looking Left

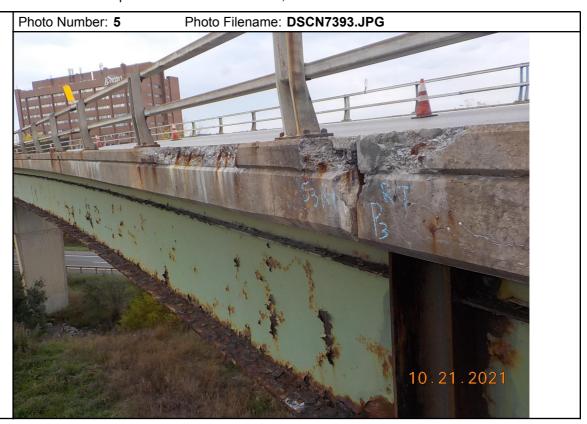
Span 4: There is 2' L X FH of the coping X 3" D spall with exposed corroded rebar at the begin of span 4 Pier 3 (Photo 5). There is also a horizontal crack with small spall up to 1" D along the right fascia of the coping from the bridge rail Post 1 to Post 3 from the end of span (pier 4) (Photo 6). At the light pole anchorage at the right the fascia coping near the end is spalled up to 3" D with exposed corroded rebar (Photo 7).

Attachment Description: Spans 3 and 4 right facia deck near Pier 3. Looking Begin Left

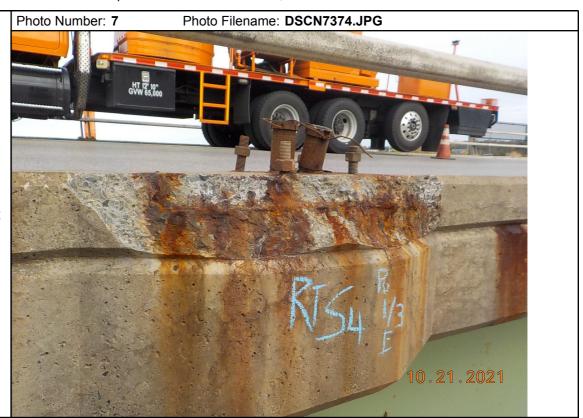
Attachment Description: Span 4 right fascia old light pole. Looking End Left

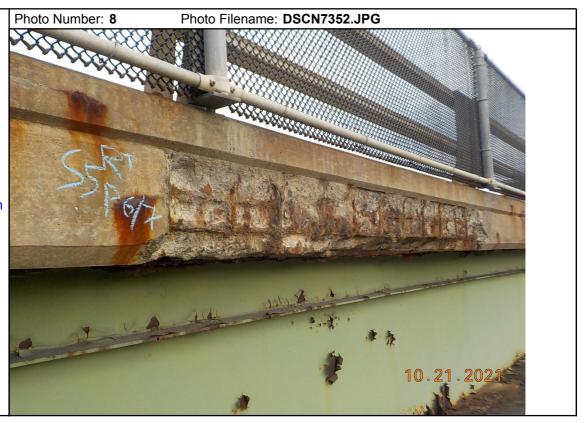
Span 5: The right fascia deck has a 10' L X FH X 3" D spall with exposed corroded rebars between bridge rail Post 6 and 7 (Photo 8).

Attachment Description:
Span 5 right fascia between
Post 6 and 7. Looking End
Left

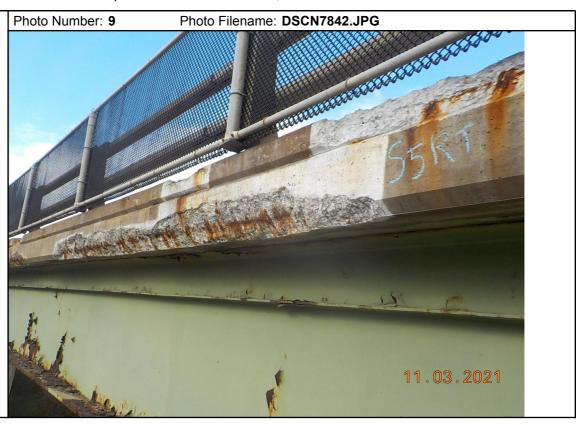
There is a 6' L X 1' H X 3" D spall with exposed corroded rebars below post 9. The right fascia deck has a 15' L X 1' H X 3" D spall with exposed corroded rebars between bridge railing Post 10 and 12 (Photo 9).

There are also multiple spalls up to 8' L X 1' H X 2.5" D with exposed corroded rebars along the right fascia of the coping from the bridge rail Post 9 to the end in scattered locations. Loose concrete was removed during the inspection (Photo 9).

Attachment Description: Span 5 right fascia deck between Posts 9 -12 Over I 481 NB ramp. Looking Begin Left

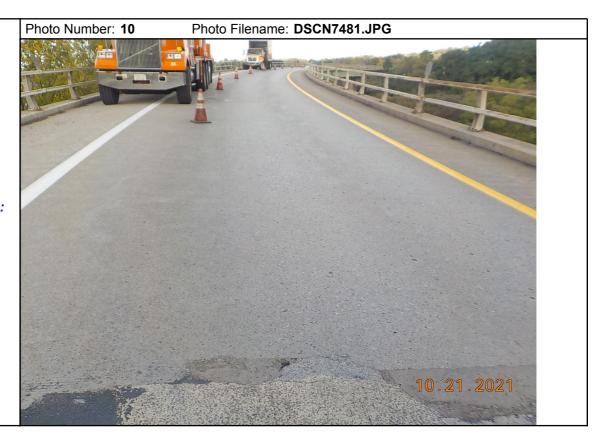
Attachment Description: Span 1 wearing surface. Looking End

The wearing surface is integral with the deck. The wearing surface is worn smooth along the wheel paths in all 5 spans (Photo 10). There are a few transverse/random cracks open up to 1/8" throughout. There are some pop-outs up to 2" dia. x 1" deep at spans 3 and 4 (Photos 12,13). There are also asphalt and concrete patched that are starting to deteriorated in spans 2 and 3 (Photo 11). 40% is assessed CS-3. The remaining is assessed CS-2.

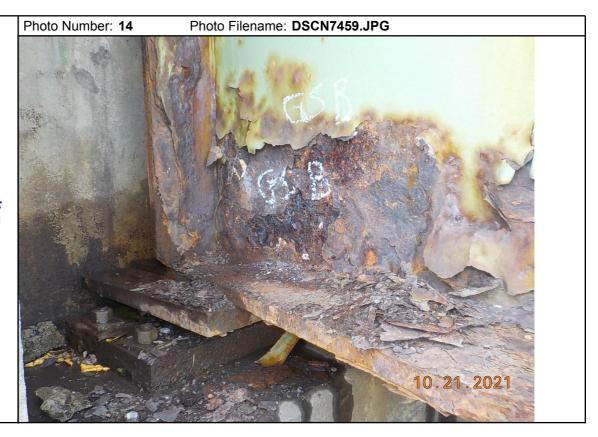
Attachment Description:Girder 5 at begin. Looking
Begin Left

Span 1 -Girder 5 at begin abutment - 21% (New) (Photo 14)

The paint system on the steel girders has failed / starting to fail allowing corrosion to occur in all spans. The worst paint failure is on the outboard faces of the fascia girders, bottom flanges and near leaking joints (Photos 14-25). 20% each assessed CS-3 and CS-4. The rest of the paint is dull and assessed CS-2.

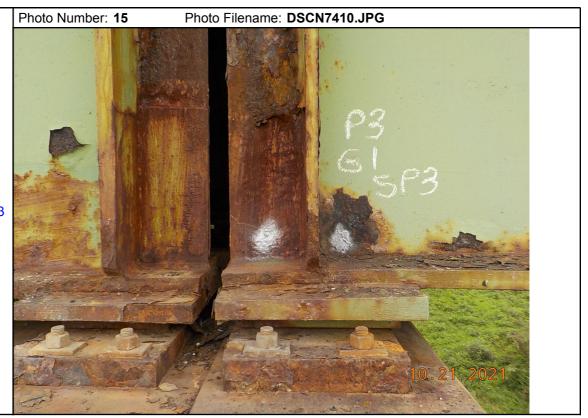
Attachment Description: Span 3 Girder 1 over Pier 3 left. Looking Right

Span 3 – Girder 1 at Pier 3 - 29% (No change) (Photo 15).

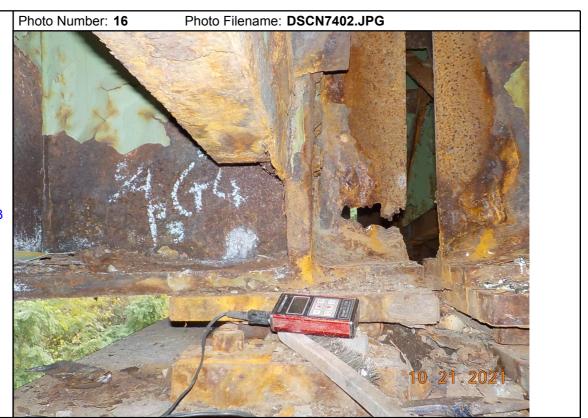
Attachment Description: Span 4 Girder 4 over pier 3 left. Looking Right

Span 4 – Girder 4 at Pier 3 – 23% (13% in 2019) (Photo 16). There is a 4.5" long X 1.5" high perforation in the lower web tail area beyond the stiffeners.

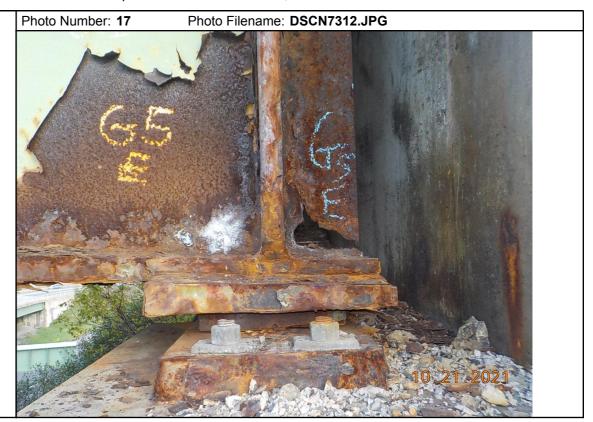
Attachment Description: Girder 5 right at end. Looking Left

Span 5 – Girder 5 at end abutment - 20% (No change) (Photo 17). There is a 4.5" long X 1.75" high perforation in the lower web tail area beyond the stiffeners.

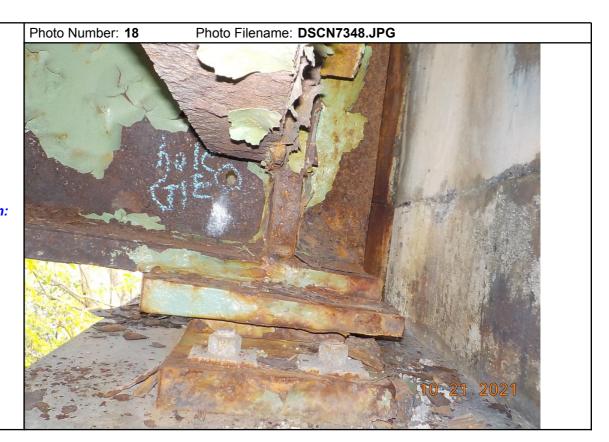
Attachment Description: Girder 1 right at end. Looking Left

Span 5 – Girder 1 at end abutment - 10% (New) (Photo 18). There is 1" Dia. perforation in the lower web. Similarly, Girder 4 at end abutment has up to 10% (Photo 19).

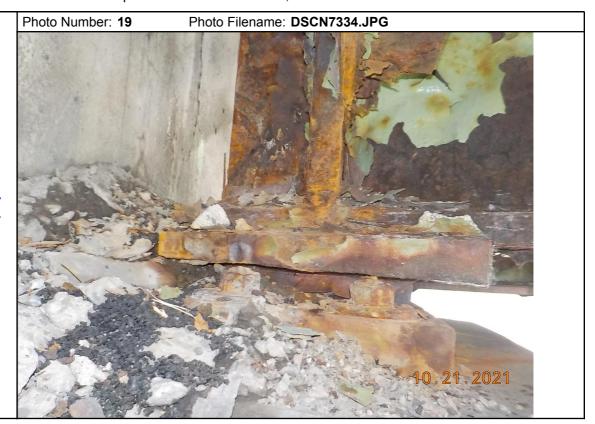
Attachment Description: Girder 4 left and bearing 4 at end. Looking Right

The paint of the bearings at the end abutment has failed allowing corrosion to occur on the surface (Photos 19, 36). 25% is assessed CS-4. The rest of the paint on the bearings is dull and is starting to fail and is assessed CS-3.

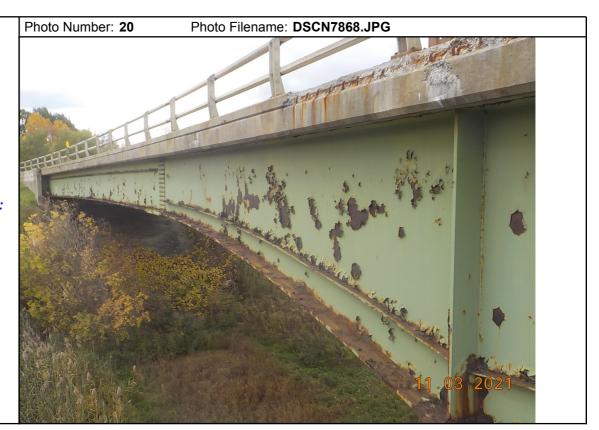
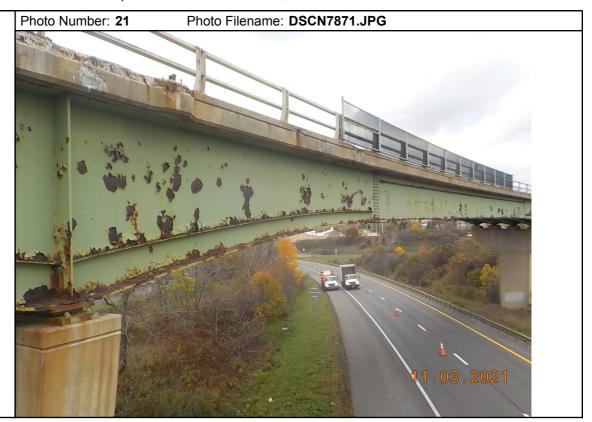
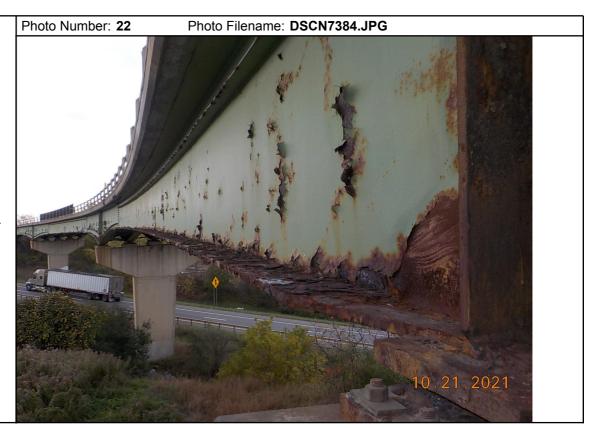
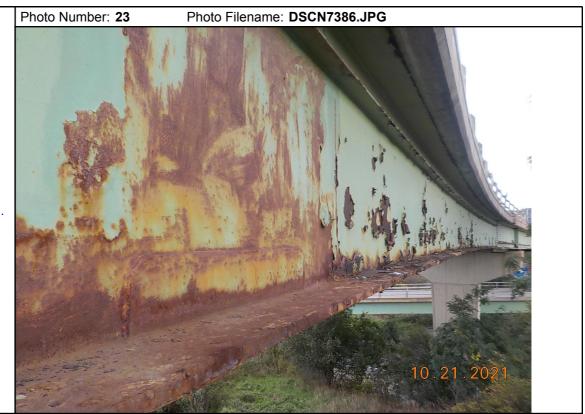
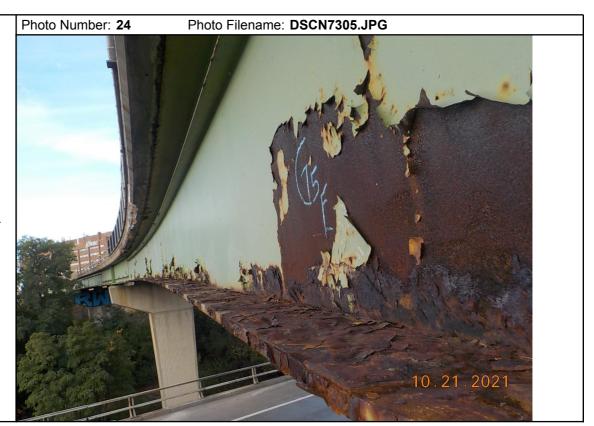
In addition, there is heavy active corrosion and delamination in the scattered areas along the lower web above the bottom flange in all span's fascia girders (Photos 20-24). Overall average web section loss is less than 5% at all locations. See Girder End Web Section Loss documentation.

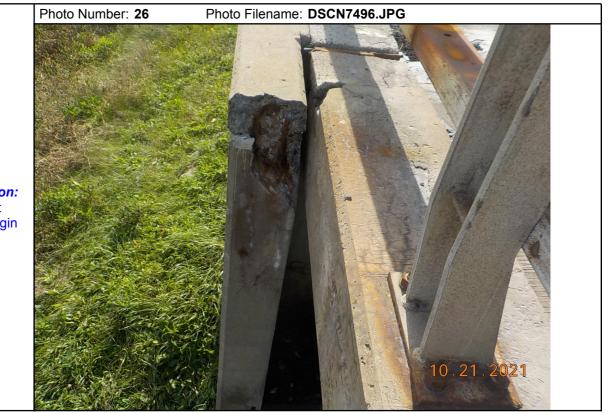
Attachment Description: Begin right abutment at cheek wall. Looking Begin

The begin right cheek wall (included as part of the abutment) is spalled/delaminated up to 2 SF X 4" D with corroded rebars at its end face at the top 1.5' of its height (Photo 26). 1 LF is assessed CS-3. The remaining is assessed CS-1 and CS-2.

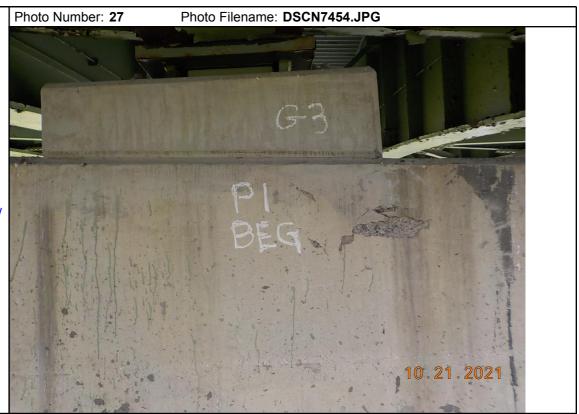
Attachment Description:
Pier 1 begin face cap below
Girder 3. Looking End

Pier 1 - There is a up to 2 SF delaminated/spalled area located below G3 pedestal at begin face of Pier 1 cap beam (Photo 27). There is also a small shallow spall located below G4 pedestal at the begin face cap beam. 2 LF is assessed CS-3. The remaining is assessed CS-1.

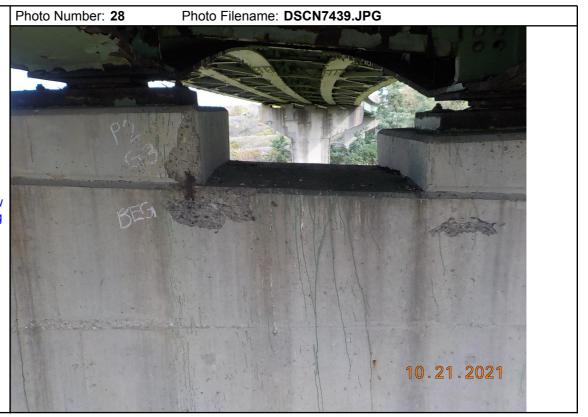
Attachment Description:
Pier 2 begin face cap below
G3 and pedestal 3. Looking
End

Pier 2 – There are two up to 1 SF delaminated/spalled area located below G3 and G4 pedestals at begin face of Pier 2 cap beam (Photo 28). There are multiple small spalls up to 1 SF X 1.5" D with exposed corroded rebar near the top below G3 pedestal at the end face of Pier 2 cap beam (Photo 29). 8 LF is assessed CS-3. The remainder is in CS-2.

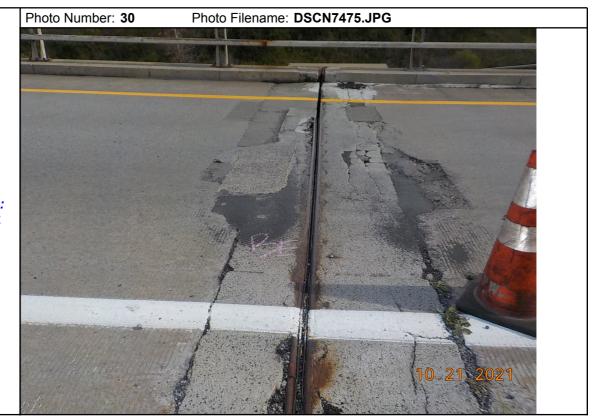
Attachment Description: Begin joint. Looking Right

The begin joint seal deteriorated for the entire length and is depressed up to 1" below the top of the headers (Photo 30). The right 8' of the joint seal is missing on the right 6' and the daylight can be seen (Photo 31). The joint leaks for the full length. The worst leakage is at the right 10' of the abutment.

The concrete header on the backwall side is deteriorated with several cracks. The entire length is assessed CS-4.

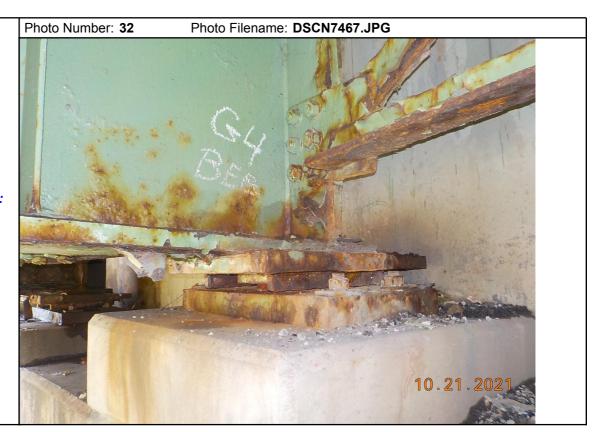
Attachment Description:
Bearing 4 at begin
abutment. Looking Begin
Right

The paint of the bearings at the begin abutment has failed allowing corrosion to occur on the surface (Photo 32). 20% is assessed CS-4. The rest of the paint on the bearings is dull and is starting to fail and is assessed CS-3.

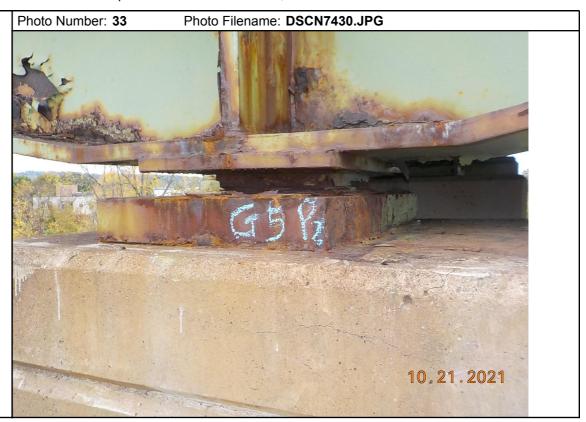
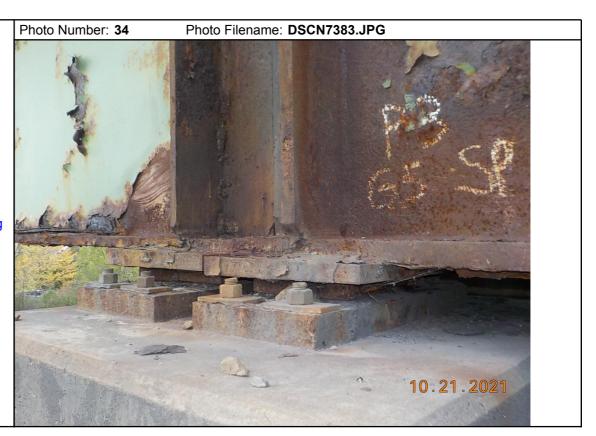
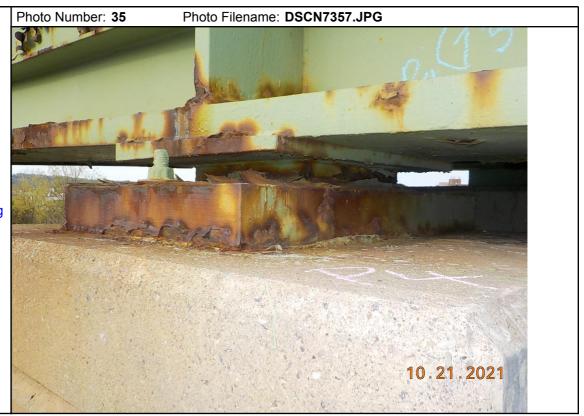
The paint of the bearings at the piers 2 and 3 has failed allowing corrosion to occur on the surface (Photos 33-35). 60% is assessed CS-4. The rest of the paint on the bearings is dull and is starting to fail and is assessed CS-3. A similar 20% paint failure on the bearings at pier 4 with the remaining paint on the bearings is dull and is starting to fail and is assessed CS-3.

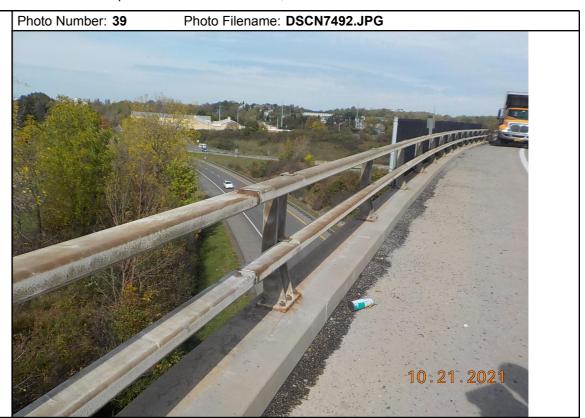
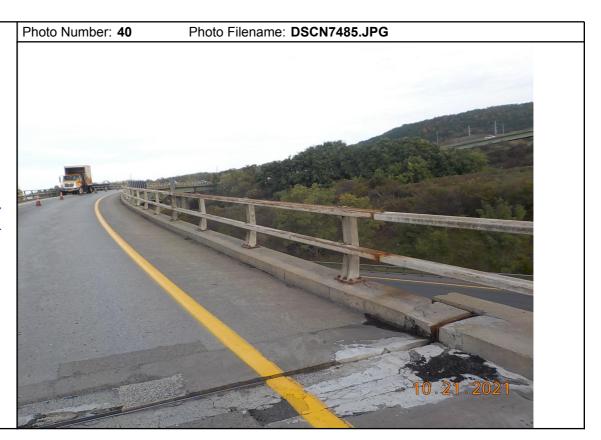
The galvanized coating of the left and right bridge railing in all spans has failed and allowing surface corrosion to form (Photos 39, 40). 30% is assessed CS-4. The rest of the galvanized coating is dull and starting to fail and is assessed CS-3.

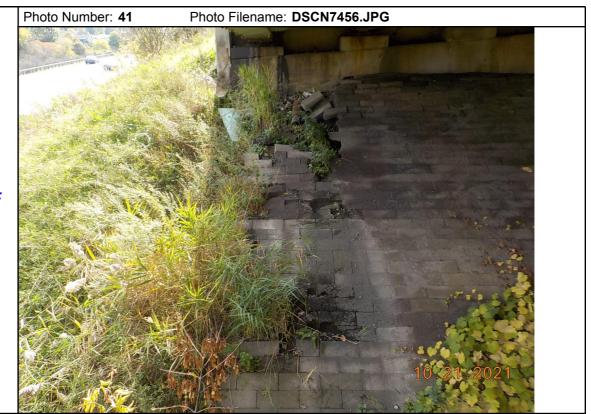
Attachment Description:
Begin abutment slope
protection at right

The begin abutment slope protection has displaced/settled and deteriorated concrete pavers for the right 10' length. Settlement is up to 1.5'. No abutment footing is exposed (Photo 41). 10 LF is assessed CS-3. The remaining is assessed CS-2.

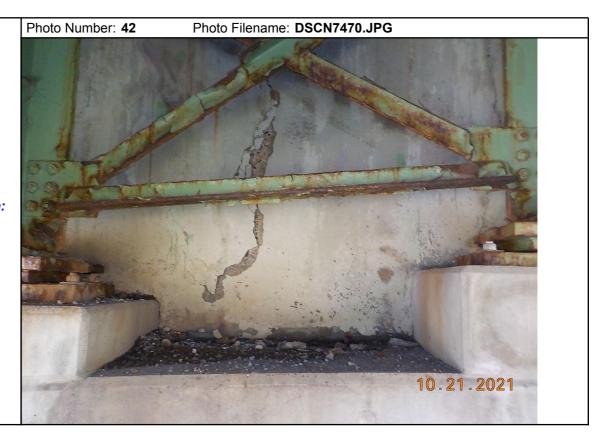
Attachment Description:
Begin abutment bay 3.
Looking Begin

The begin abutment backwall has a 2' wide by 4' high delaminated area in bay 3 (Photo 42). There is also a full height vertical crack up to 1/16" wide just right of G4 in Bay 4. 3 LF is assessed CS-3. The remaining is assessed CS-2.

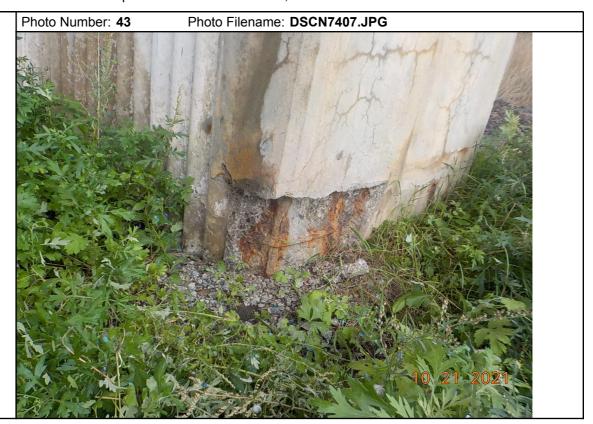
Attachment Description:
Pier 3 end left corner.
Looking Begin Right

There is a 2.0' L X 1.5' H X 3" deep with exposed corroded reinforcing at the base of the end left corner of Pier wall (Photo 43). 2 LF is assessed CS-3. The remaining is assessed CS-2.

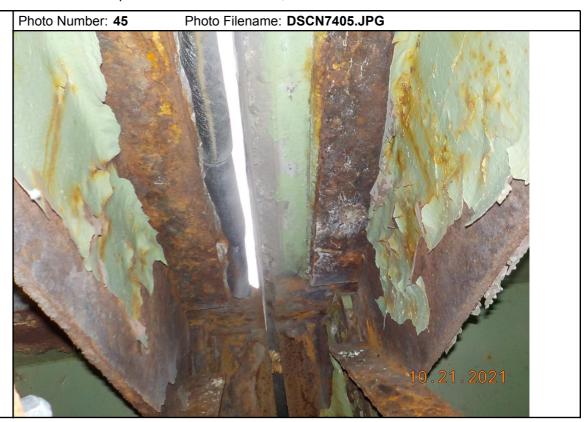
Attachment Description:
Pier 3 joint underside bays
3 and 4. Looking Right

The right 10' of the joint seal is missing (Photo 44) and the daylight can bee seen from the underside joint (Photo 45). The rest joint seal remains fair. Since the last inspection the concrete header appears to be repaired with small asphalt patched. 10 LF is assessed CS-4. The remaining is assessed CS-2.

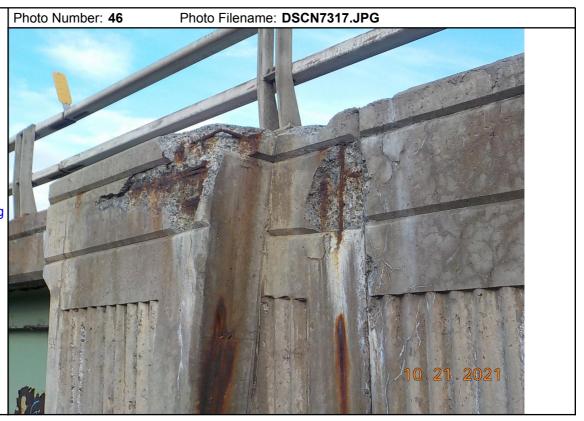
Attachment Description: End right abutment. Looking Begin Left

At the top of the end right cheek wall (assessed as abutment) there is spalled/delaminates for up to 5' length X 4" deep with exposed corroded reinforcing (Photo 46). Also, there are a few other cracks with efflorescence and minor spalls. 8 LF is assessed CS-3. The remaining is assessed CS-2.

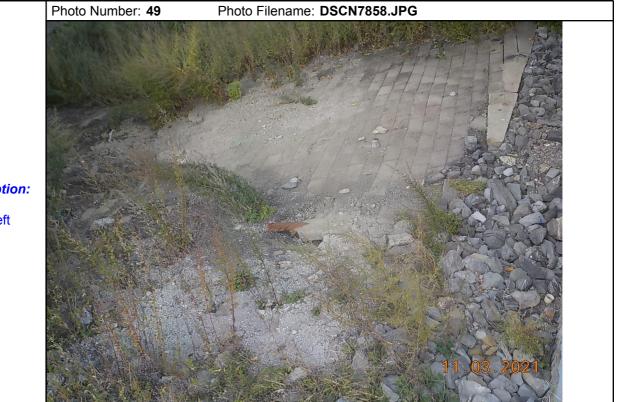
Attachment Description: End abutment slope protection Looking Left

There are concrete pavers and small to medium stone filling protecting the end abutment slope. Concrete pavers are heavily spalled and/or missing throughout the end abutment slope (Photo 49). 30 LF is assessed CS-3. The remaining is assessed CS-2.

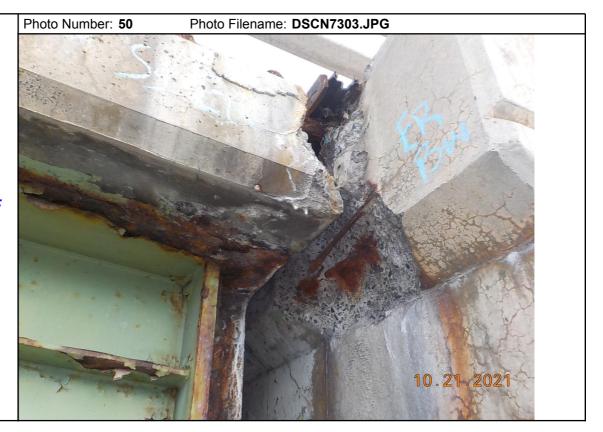
Attachment Description: End abutment backwall at right. Looking End Left

At the end abutment backwall there is spalled up to 4" deep with exposed reinforcing below the right deck overhang for approximately 2' length by 1.5' of height (Photo 50). 3 LF is assessed CS-3. The remaining is assessed CS-2.

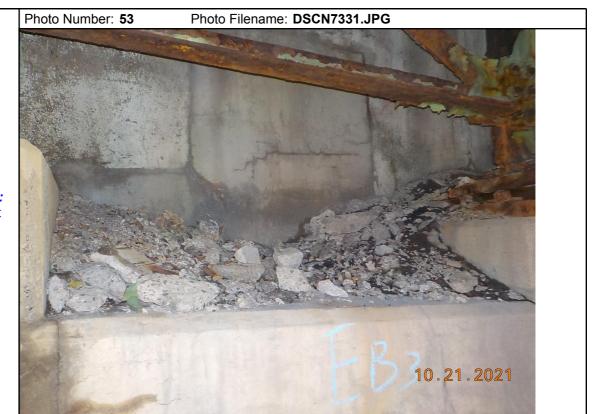
Attachment Description: End abutment bridge seat bay 3. Looking End Right

End abutment bridge seat bay 3 has a buildup of debris fallen from deteriorated joint (Photo 53).
