New York State Department of Transportation General Bridge Inspection Report

Inspection Date: November 03, 2021

BIN: 1069090
 Region: 03 - SYRACUSE

Feature Carried: I481 SB TO I81 SB
 County: ONONDAGA

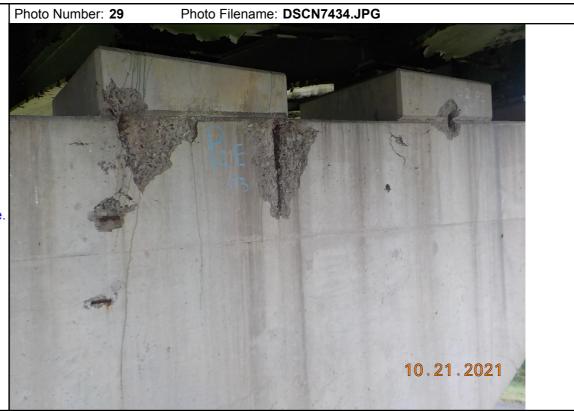
Attachment Description:
Pier 2 end face cap below
G3 and pedestal 2 end face.
Looking Begin

The end faces of G2 and G3 pedestals at Pier 2 have up to 1 SF of surface spalling up to 1.5" deep with exposed corroded rebars (Photo 29). Also, the begin right corner of the G3 pedestal at Pier 2 is spalled up to 1.5" deep X full height X 5" wide (Photo 28). The right one half of the end face of G5 pedestal is map cracked and delaminated. 3 pedestals are assessed CS-3. The remaining is assessed CS-2.

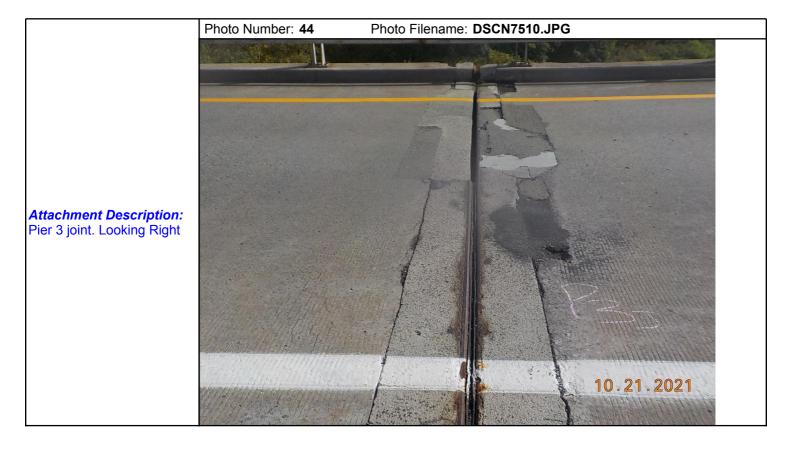
Attachment Description:
Pier 3 joint underside bays
3 and 4. Looking Right

The right 10' of the joint seal is missing (Photo 44) and the daylight can bee seen from the underside joint (Photo 45). The rest joint seal remains fair. Since the last inspection the concrete header appears to be repaired with small asphalt patched. 10 LF is assessed CS-4. The remaining is assessed CS-2.

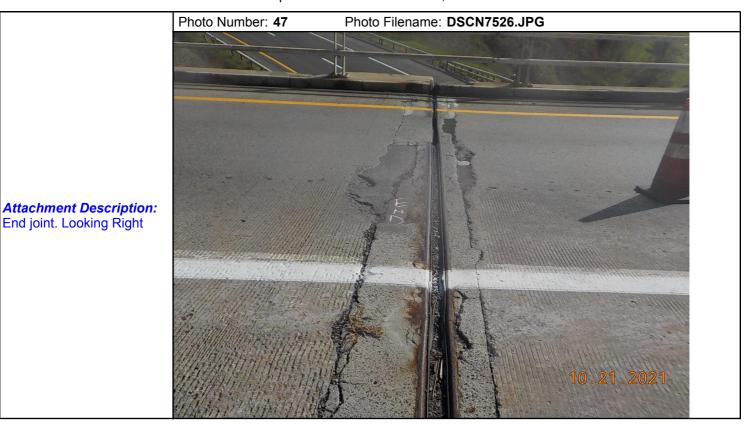
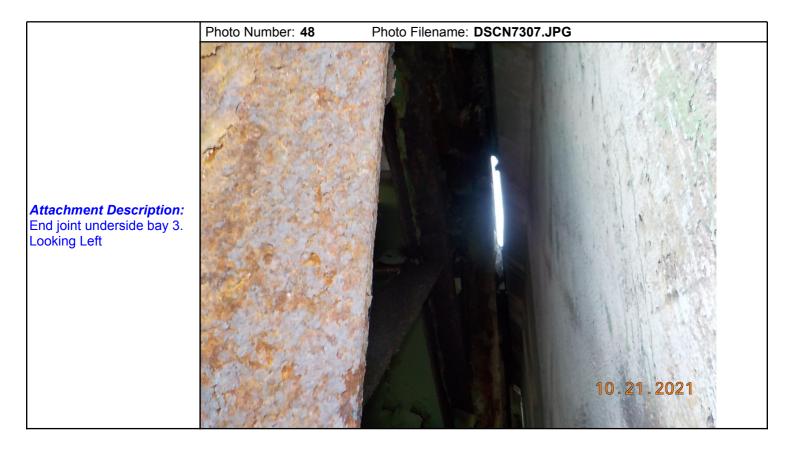
The end joint seal deteriorated for the entire length and is depressed up to 1" below the top of the headers and filled with debris. The right of the joint seal is missing on the right 6' and the daylight can be seen (Photos 47, 48). The joint leaks for

the full length. The worst leakage is at the right 6' of the abutment.

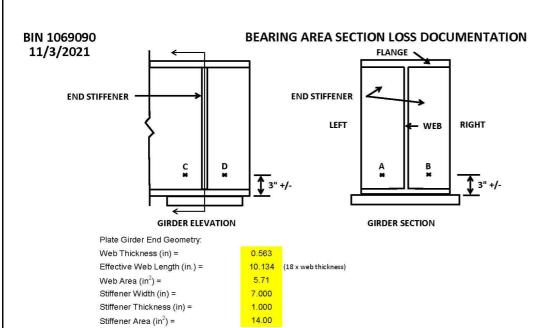
Origin	al Beam				Sp	an 3 Pier 3	G1		
Dv	Date	Location	Stiff	ener	W	eb	SECTION	I LOSS SI	JMMARY
Ву	Date	Location	Α	В	С	D	Stiffeners	Web	Total
MG/CU	10/25/19	Span 3 G1 Pier 3	0.875	0.7	0.4	0.188	21%	48%	29%
DGM/TM	11/03/21	Span 3 G1 Pier 3	0.850	0.7	0.425	0.188	23%	46%	29%
DGM/TM	11/03/21	G5 at Begin	0.875	0.8	0.475	0.285	16%	33%	21%
					Ĭ		1 1

Web Thickness (in) = 0.375
Effective Web Length (in.) = 6.750
Web Area (in²) = 2.53
Stiffener Width (in) = 7.000
Stiffener Thickness (in) = 1.500
Stiffener Area (in²) = 21.00
